# Army Lodging Wellness Recommendation

## Final Submittal - White Sands Arsenal

February 13, 2004

# White Sands Missile Range

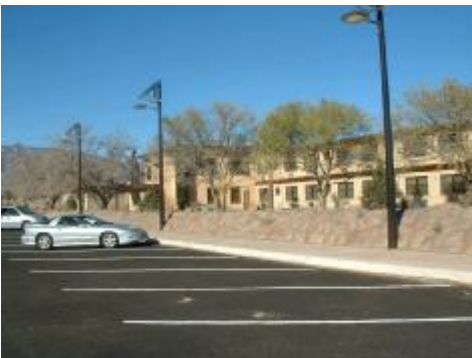
### ***Building 00501***

Building 501, constructed in 1950, serves as the Main Lodging facility for the White Sands installation. This facility houses 22 standard stay rooms and 2 family suites as well as a portion of the public and back-of-house areas, including the front desk, lobby and administrative offices. There are additional departmental offices currently being housed in the west portion of the facility, including the Housing department. Although this building was renovated in 1998 and is in fair condition, it does not meet Lodging standards and cannot be reconfigured without significant reconstruction. To renovate Building 501 to the new standards and configuration will exceed 50% of the replacement cost.

It should be noted that this structure may be historic and some Army Lodging functional requirements indicated in the report would require clearance from the SHPO or through Army Alternate Procedures; therefore, some of the requirements may need modification, in which case the prices for implementation may vary from the cost models applied.

Our recommendation is to remove building 501 from the Lodging inventory, allowing the installation to determine an alternate use for this facility. This facility will be removed from the White Sands Missile Range Wellness Solution and Lodging Master Plan.

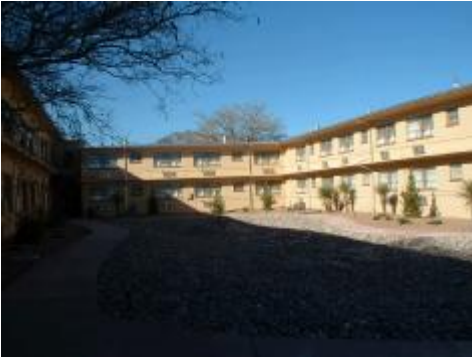
#### ***Building 00502***

Building 502, constructed in 1952, is a 2-story structure housing 19 family suites. This facility was built as an addition to the original Main Lodging facility, building 501, and includes several back-of-the-house areas which serve both facilities. Although this building was renovated in 1998 and is in fair condition, it does not meet the demand requirements of only 3 family suites, and cannot be reconfigured to the standard/extended stay rooms without significant reconstruction. To renovate building 502 to the new configuration will exceed 50% of the replacement cost.

It should be noted that this structure may be historic and some Army Lodging functional requirements indicated in the report would require clearance from the SHPO or through Army Alternate Procedures; therefore, some of the requirements may vary from the cost models applied.

Our recommendation is to remove building 502 from the Lodging inventory, allowing the installation to determine an alternate use for this facility. This facility will be removed from the White Sands Missile Range Wellness Solution and Lodging Master Plan.

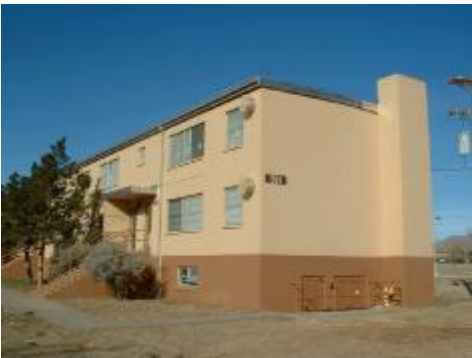
#### ***Building 00504***

Building 504, constructed in 1959, is a shared facility housing 3 family suites. These rooms do not meet Lodging standards and can not be reconfigured without significant reconstruction. Building 504 is scheduled to be removed from the Lodging inventory in FY04, and was not assessed.

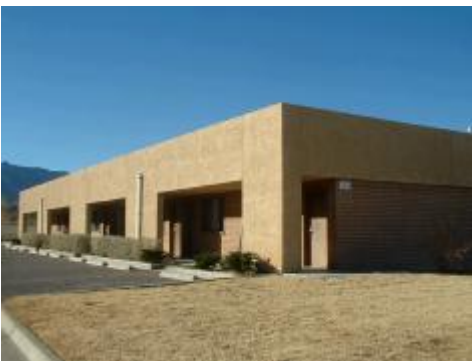
#### ***Building 00506***

Building 506, constructed in 1986, houses 15 extended stay rooms. Although this building was renovated in 1996 and is in fair condition, many support spaces do not exist and the existing room size is slightly larger than standards. To renovate building 506 to include the appropriate support spaces and meet standards will not exceed 50% of the replacement cost.

The Wellness Recommendation is to retain building 506 in the White Sands Lodging inventory. This facility will remain in the White Sands Missile Range Wellness Solution and Lodging Master Plan.

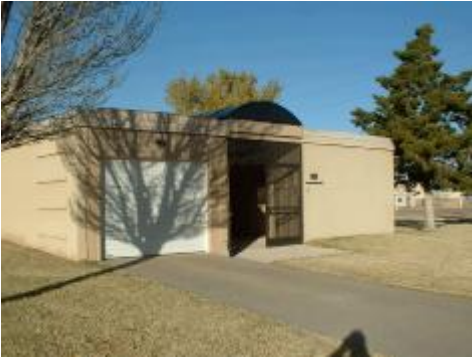
### ***Building 12333***

Building 12333, constructed in 1958, is a one family suite structure. This unit contains a full kitchen, dining area, living room, bathroom and three bedrooms. Although renovated in 1996, this facility does not meet Lodging standards and cannot be reconfigured without significant reconstruction. To renovate Building 12333 to the new standards and configuration would exceed 50% of the replacement cost.

Our recommendation is to remove building 12333 from the Lodging inventory, allowing the installation to determine an alternate use for this facility. This facility will be removed from the White Sands Missile Range Wellness Solution and Lodging Master Plan.

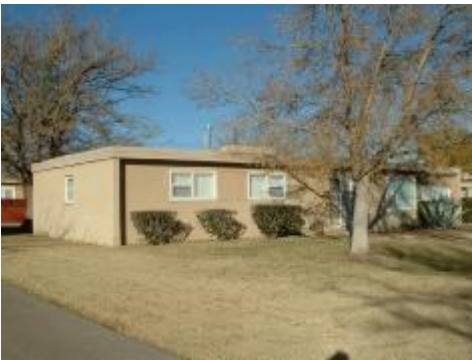
### ***Building 12334***

Building 12334, constructed in 1958, is a one family suite structure. This unit contains a full kitchen, dining area, living room, bathroom and three bedrooms. Although renovated in 1996, this facility does not meet Lodging standards and cannot be reconfigured without significant reconstruction. To renovate Building 12334 to the new standards and configuration would exceed 50% of the replacement cost.

Our recommendation is to remove building 12334 from the Lodging inventory, allowing the installation to determine an alternate use for this facility. This facility will be removed from the White Sands Missile Range Wellness Solution and Lodging Master Plan.

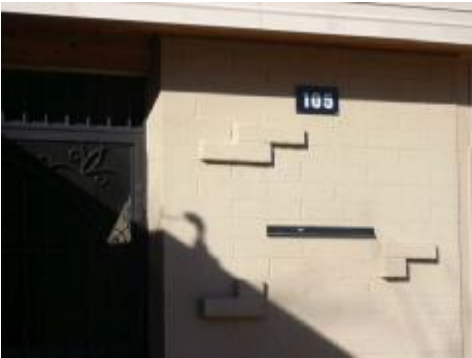
### ***Building 12335***

Building 12335, constructed in 1958, is a one family suite structure. This unit contains a full kitchen, dining area, living room, bathroom and three bedrooms. Although renovated in 1996, this facility does not meet Lodging standards and cannot be reconfigured without significant reconstruction. To renovate Building 12335 to the new standards and configuration would exceed 50% of the replacement cost.

Our recommendation is to remove building 12335 from the Lodging inventory, allowing the installation to determine an alternate use for this facility. This facility will be removed from the White Sands Missile Range Wellness Solution and Lodging Master Plan.

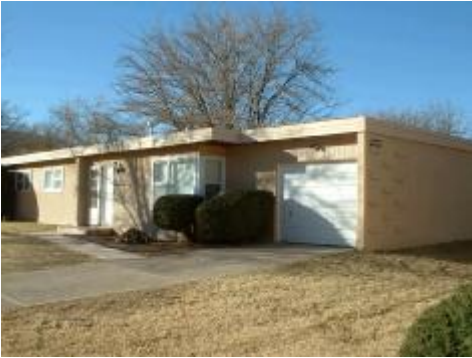
### ***Building 12336***

Building 12336, constructed in 1958, is a one family suite structure. This unit contains a full kitchen, dining area, living room, bathroom and three bedrooms. Although renovated in 1996, this facility does not meet Lodging standards and cannot be reconfigured without significant reconstruction. To renovate Building 12336 to the new standards and configuration would exceed 50% of the replacement cost.

Our recommendation is to remove building 12336 from the Lodging inventory, allowing the installation to determine an alternate use for this facility. This facility will be removed from the White Sands Missile Range Wellness Solution and Lodging Master Plan.

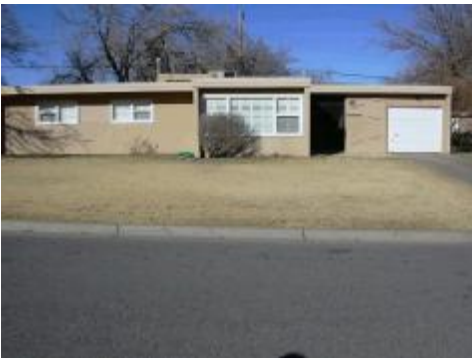
### ***Building 12337***

Building 12337, constructed in 1958, is a one family suite structure. This unit contains a full kitchen, dining area, living room, bathroom and three bedrooms. Although renovated in 2002, this facility does not meet Lodging standards and cannot be reconfigured without significant reconstruction. To renovate Building 12337 to the new standards and configuration would exceed 50% of the replacement cost.

Our recommendation is to remove building 12337 from the Lodging inventory, allowing the installation to determine an alternate use for this facility. This facility will be removed from the White Sands Missile Range Wellness Solution and Lodging Master Plan.

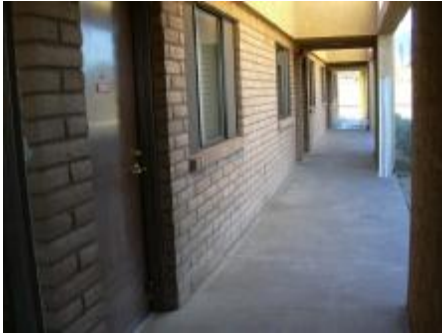
Bldg 506  
Exterior Walkway  
White Sands Missile Range, NM

- Analysis: The outer exterior covered walkway system is of reinforced concrete and stucco, in good condition. The inner exterior wall enclosure is decorative 4x16 face concrete masonry units (CMU). There is cracking in the masonry joints in several places.
- Recommendation: Repair mortar joints in CMU walls.

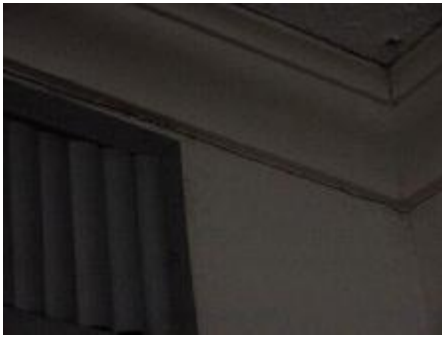
100 Goddard  
Ceiling Damage  
White Sands Missile Range, NM

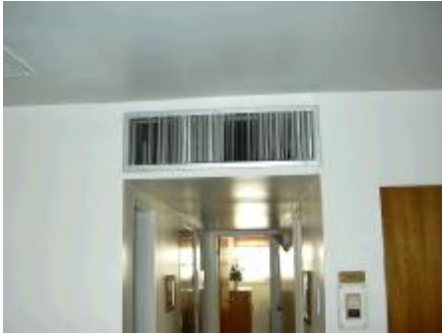
102 Goddard  
Single House Air Supply Duct  
White Sands Missile Range, NM

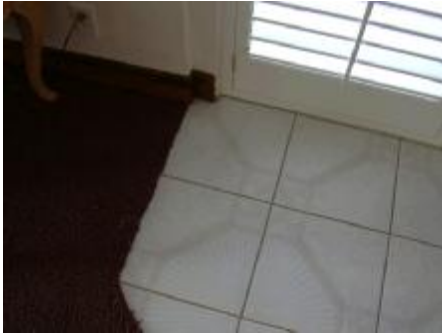
110 Goddard  
Floor by Patio Door  
White Sands Missile Range, NM
